# AN ELECTRON ACCELERATOR ACCIDENT IN HANOI, VIET NAM

INTERNATIONAL ATOMIC ENERGY AGENCY  
VIENNA, 1996

Nevertheless, on occasions safety systems or procedures are ignored or bypassed and serious radiological consequences ensue. On 17 November 1992 one such event took place at an electron accelerator facility in Hanoi, Viet Nam. An individual, entering the irradiation room without the operators' knowledge, unwittingly exposed his hands to the X ray beam. His hands were seriously injured and one had to be amputated.

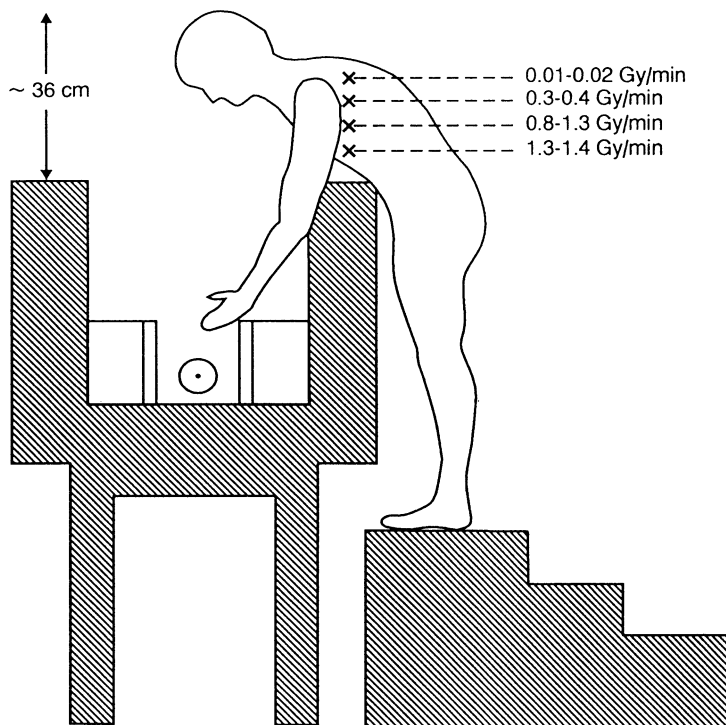
The operator and the assistant ran back to the accelerator room. The door was open about 60 cm, and they saw the director handling some wax blocks at the corner of the maze. Not realizing what had happened, the director calmly proceeded outside to wash his hands. When informed that the accelerator had been switched on a few minutes earlier, possibly whilst he had been in the room, he went very quiet, but at this point it was not clear whether in fact he had been exposed.

FIG. 6. Diagram of exposure position.

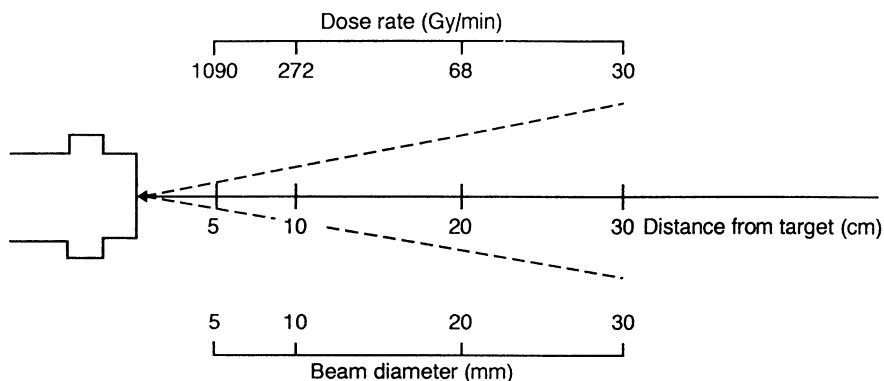
FIG. 7. Dose rates in the accelerator beam.

The results should be treated with caution. The measurements showed very steep gradients, both at the edge of the wooden box over which the exposed man was leaning and close to the tungsten target where his hands would have been. To complicate matters, film badge measurements of scattered radiation indicated a wide energy spectrum of both photon and electron radiation from bremsstrahlung in accelerator components such as bending magnets and the guide tube, from target backscatter and from scatter off lead shielding. Moreover, buildup under the skin of dose rates from high energy photon and electron radiation (maximum dose rates might be several centimetres beneath the skin, depending on radiation energy and type) also affects dose estimates. (Physical dosimetry measurements made two months later on day 185 (20 May) by HINP indicated that the dose rate at the approximate location of the patient's thorax did not exceed 2.4 Gy/min at 10 cm depth.)

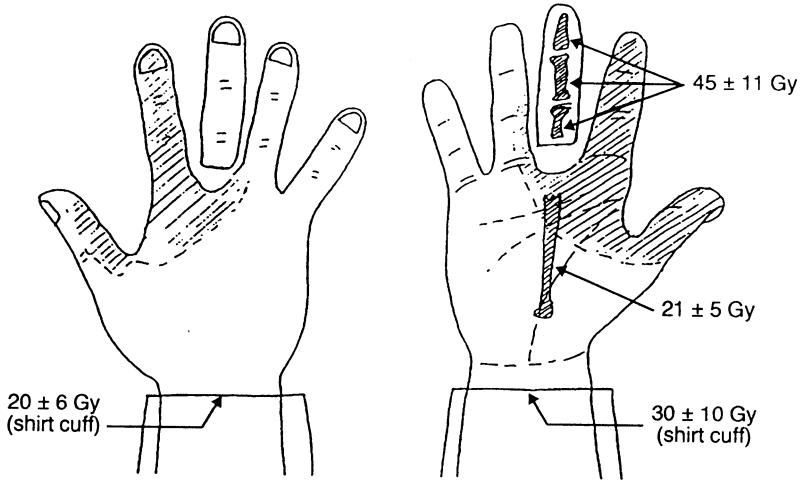
FIG. 8. ESR estimated dose to right hand.

**ESR measurements.** As noted above, the patient's amputated bone and the shirt he was wearing when exposed were sent, at the suggestion of the IAEA team, to the Institute of Biophysics in Moscow for ESR analysis. The results on days 191 and 202 (26 May and 6 June 1993) on bone samples were that the mean dose to the third right finger was  $45 \pm 11$  Gy, with a  $21 \pm 5$  Gy mean dose to the third right metacarpus. On the basis of ESR measurements of the cuffs of the patient's shirt, the estimates were  $30 \pm 10$  Gy to the outer (cuff link area) wrist of the right hand and  $20 \pm 6$  Gy to the inner part (see Fig. 8) and  $8 \pm 3$  Gy to the left wrist.

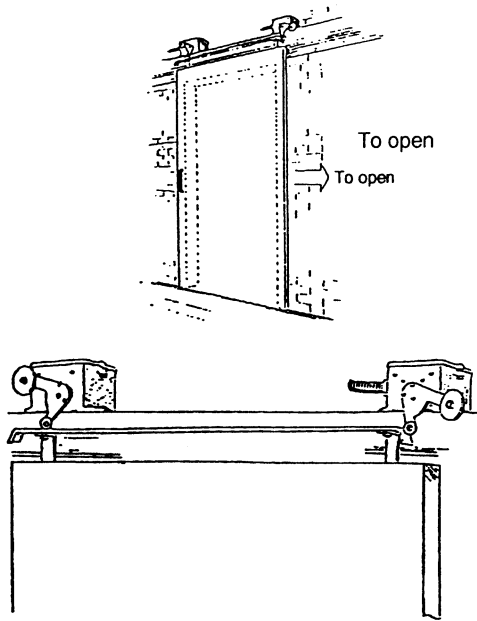
FIG. 9. Sliding door mounting method. (The use of two position switches, one with contacts normally open and the other with contacts normally closed, provides a higher degree of safety.)

The accelerator room door must have an interlock system such that if the door is open, radiation cannot be generated, or if the door is accidentally opened

during radiation generation, generation is automatically terminated (see Fig. 9 for recommended interlock mounting method). Given the greater precaution needed in such a high radiation intensity facility, a single interlock is not sufficient, and a second interlock should be installed that operates in a different mode from the first (e.g. using mechanical position switches, with the contacts on one normally closed and the other normally open). The correct operation of any interlock system should never be assumed. Regular checks must be carried out and written records maintained.

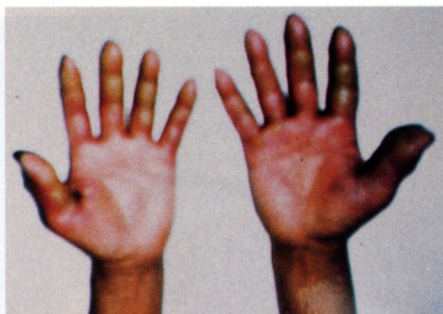
He continued to bathe his hands in salt water. On day 14, he photographed his hands to record the bright erythema and pronounced oedema, especially on the right hand (Plate 4(a)). Pain in the hands progressed day by day and vesicles on fingers appeared that turned into large bullae by day 22. Finally, he went to a specialized hospital — the NCB — on day 24 (11 December 1992) and was hospitalized with oedema, deep ulcerations and skin necrosis in both hands. The doctors were certain then that the damage was due to radiation exposure.

PLATE 4. The exposed man's hands on (a) day 14, (b) day 28 and (c) day 113.

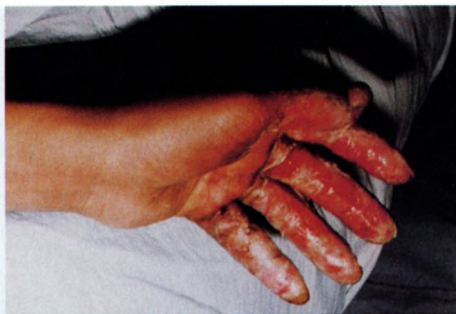
(b)

On day 28 (14 December), the patient was examined by the director of the NCB. Bullae were opened and all ‘necrotic skin’ was removed surgically, the usual method for treatment of thermal burns (Plate 4(b)). Several ‘domestic’ medicines, including something considered ‘radioprotective’, were added to the treatment. Later, the patient
